Gelled Water Bag Cookoff Tests

ARL-MR-507 March 2001

John D. Sullivan

Weapons and Materials Research Directorate, ARL

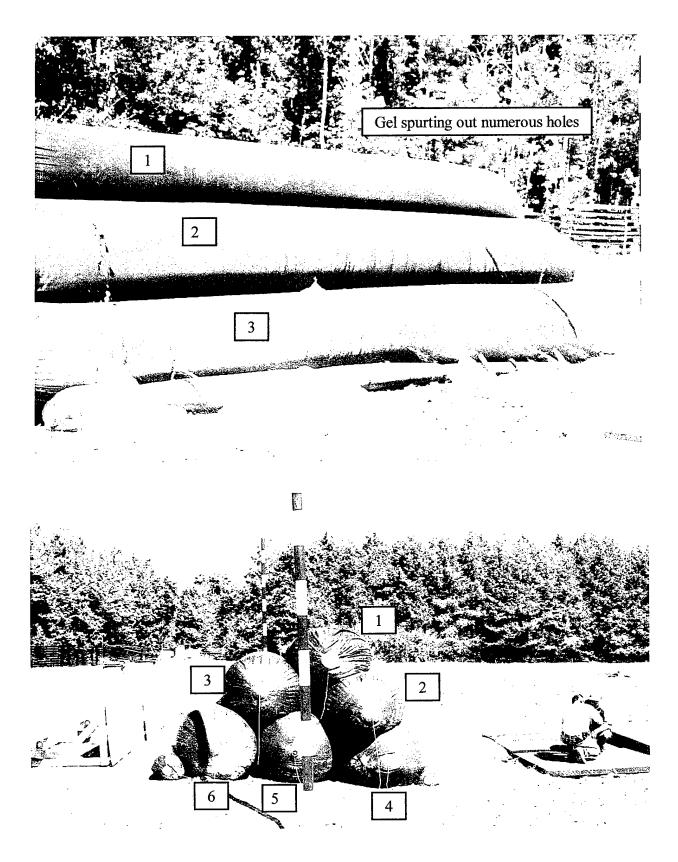
- 4.3 Results. The shot-by-shot results for the 36-in bags are in the last column of Table 1 and are shown in Figures 3-6. Shot 1 put five equispaced holes (caused by shell fragments or rocks thrown up by the blast) into the wedge bag, and gel began to flow (see Figure 3). Shot 2 perforated

Figure 3. Result of Shot 1, 36-in-Diameter Bags: Rear-Quarter View (Top) and End View (Bottom).

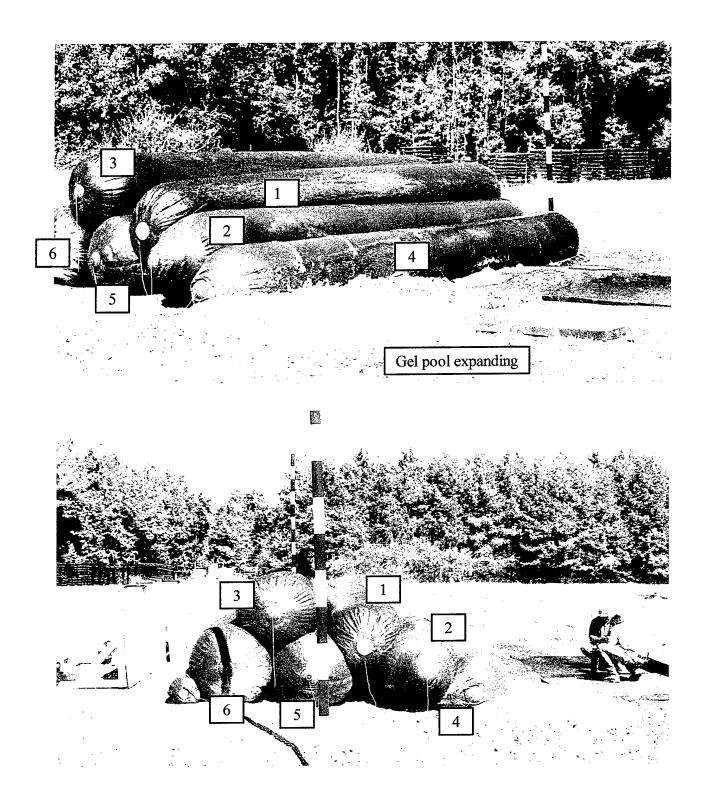
a second-layer bag (Figure 4), and shot 3 tore a large hole midbag (see Figure 5). The bags made at least one significant movement when the front wedge bag deflated moments after shot 2. With that sole restraint gone, the pile rolled, leaving only a single bag on the second layer. The bags rolling down caused a discontinuous loss of height, in addition to the steadier loss from flowing gel. Two rear ground bags were unaffected by the shots and still offered protection (see Figures 5 and 6). The amount of gel coursing over the area might have offered the unexpected benefit of putting out fires in packing boxes or smothering unburned propellant, but firefighters would not enter such an arena anyway.

Figure 4. Result of Shot 2, 36-in-Diameter Bags: Rear-Quarter View (Top) and End View (Bottom).

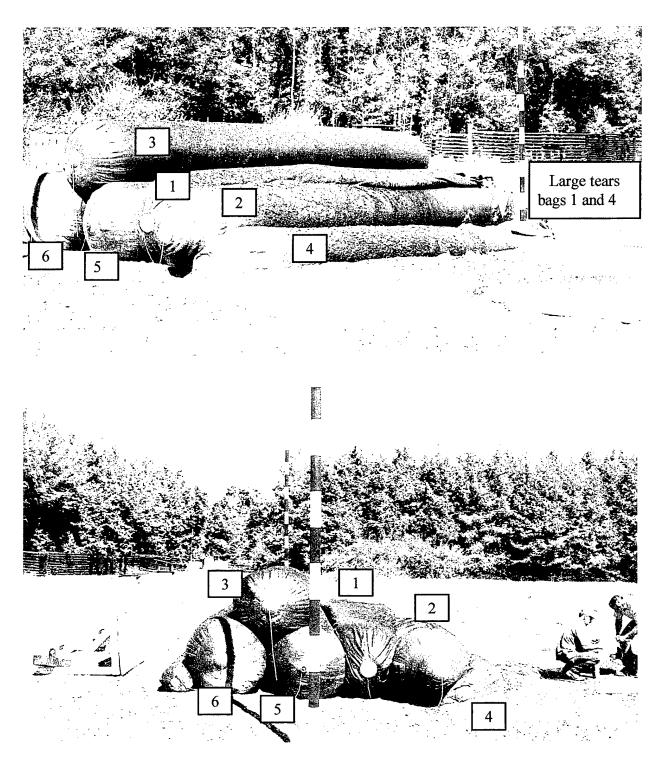
Figure 5. Result of Shot 3, 36-in-Diameter Bags: Rear-Quarter View (Top) and End View (Bottom).

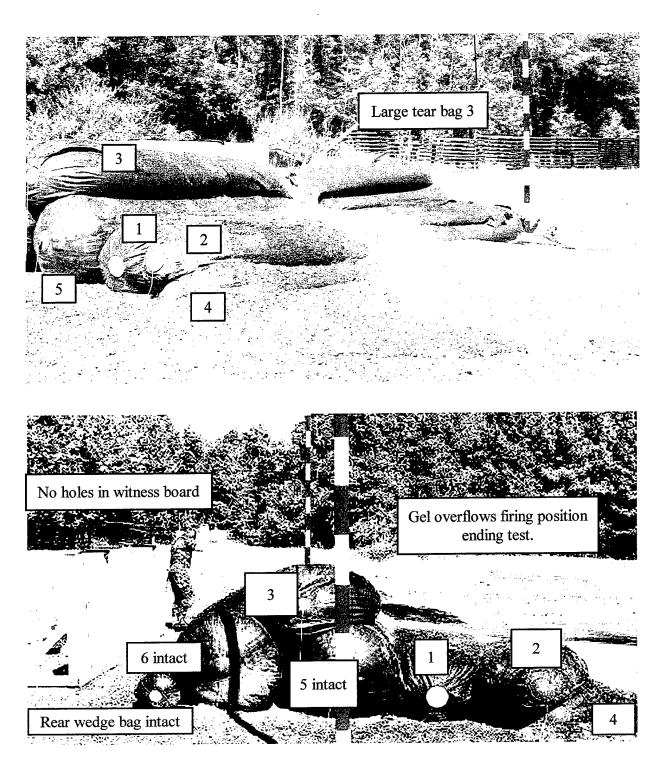
4	-2 ft, side on to bag	Upper bag takes very large hit near center. Front ground bag also hit. Huge gel pool overflows firing plate causing test to end. Three bags still up on ground. No fragment holes in plywood witness boards.

Figure 6. Result of Shot 4, 36-in-Diameter Bags: Rear-Quarter View (Top) and End View (Bottom).

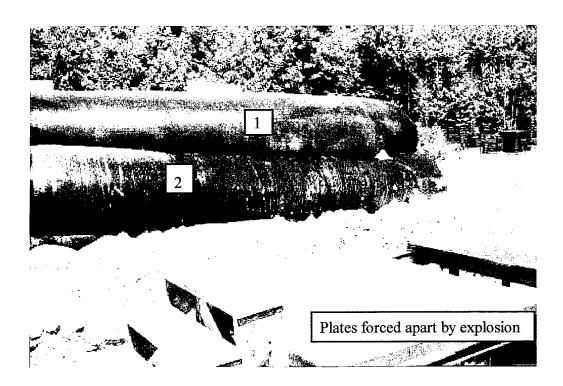
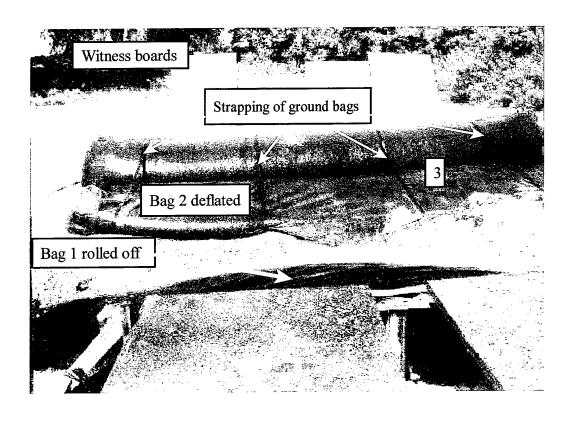
- 5.3 Results. The shot-by-shot results for the 54-in bags are in the last column of Table 2 and are shown in Figures 9-18. For the first shot, the projectile was nose on, centered at midbag. The explosion put two large holes and five small ones in the front bag. The flow stopped before the second shot was ready (5 min). In the second shot, the projectile lay 2 ft left of midbag and turned 30° left, and its explosion produced a large hole and a tall shower of gel. The front bag drained quite low at the front end, which allowed the unrestrained top bag to roll over the slippery cover and slide into the firing table. With the weight of the top bag gone, gel flow stopped from the front bag. Beginning with the third shot, the barricade was a half-empty front bag and an inflated back bag. The projectile produced few fragments through nine shots, and the back bag was never hit. No 105-mm fragments got through a bag to hit the plywood witness boards. This result was expected, since none got through the 36-in-diameter bag either. The hand-sized pieces of steel case were found; they were the most destructive to the bag because they produced long, slicing tears instead of just holes.

Figure 9. Result of Shot 1, 54-in-Diameter Bags.

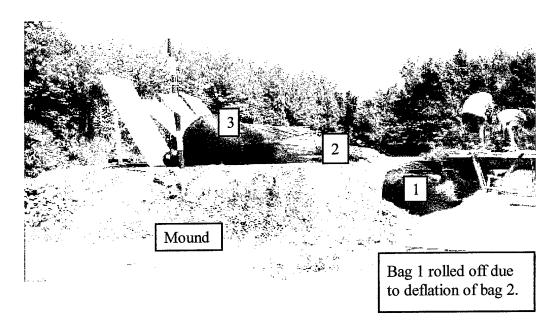
Figure 10. Result of Shot 2, 54-in-Diameter Bags: Side View (Top) and End View (Bottom).

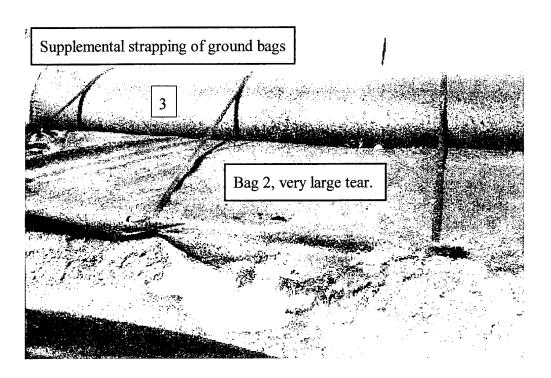
Figure 11. Result of Shot 3, 54-in-Diameter Bags.

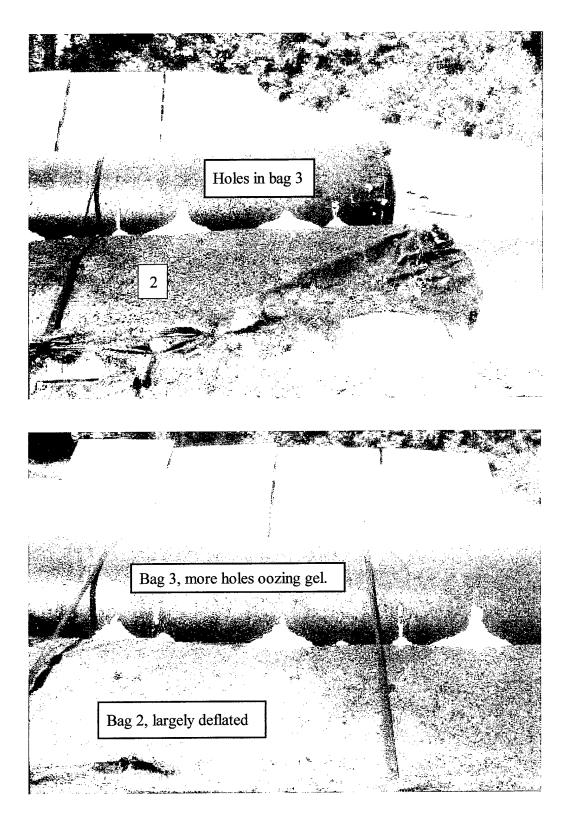
Figure 12. Result of Shot 4, 54-in-Diameter Bags: Midbag Views.

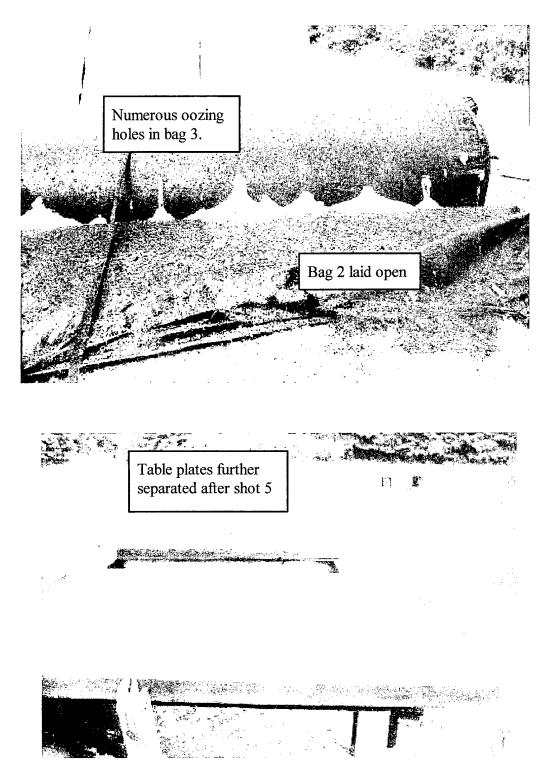
Figure 13. Result of Shot 5, 54-in-Diameter Bags: Side View (Top) and Table Separation (Bottom).

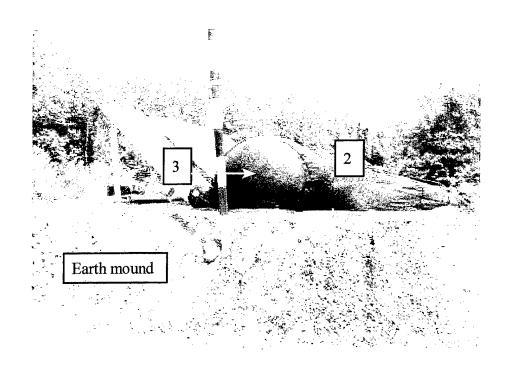
Figure 14. Result of Shot 6, 54-in-Diameter Bags.

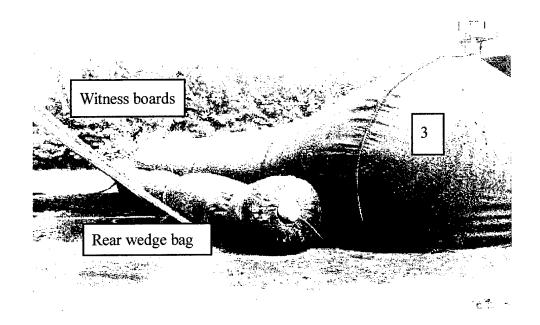
8	1 ft, turned 60° CCW	Fragment hit in big gel puddle of slashed open end. Fireball and spray well separated. Back bag 3 ft high at rear.
9	-2 ft, nose on to bag	Good splash. Fragment caught the front bag and ripped it wider

Figure 16. Result of Shot 8, 54-in-Diameter Bags.

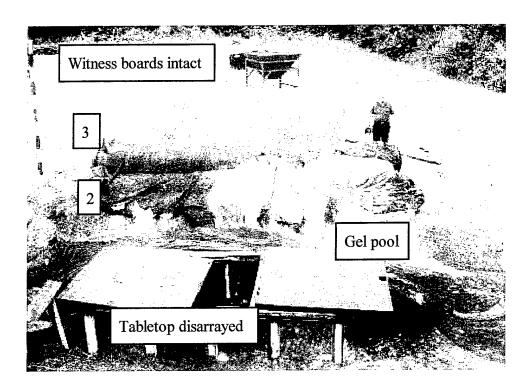
Figure 18. View After Nine Shots on 54-in-Diameter Bags.
